## Chapter Four EXTERIOR

**HISTORIC STRUCTURE REPORT  
WISCONSIN STATE CAPITOL  
CENTRAL PORTION**

## Central Portion Description

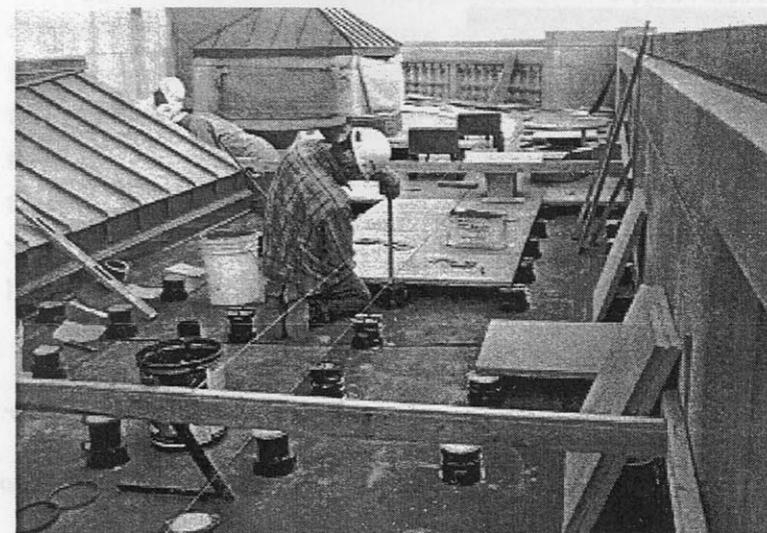
Figure 4-9  
The Observation Deck Project employed adjustable cylinders to hold the paver tiles in place.  
Photo: Joyce Inman Historic Interiors, Inc.

The 1996 Observation Deck Project involved the removal of all added materials with a return to the original concrete leveling agent above the terra cotta clay tiles. All cracks in the existing concrete were repaired and the entire surface was ground smooth. Installation included a new roof membrane with drainage mat, insulation, and an asphaltic protection board. A pedestal system, employing adjustable 4" diameter plastic cylinders, holds in place 2' x 2' red granite paver tiles, quarried in Wausau, Wisconsin.

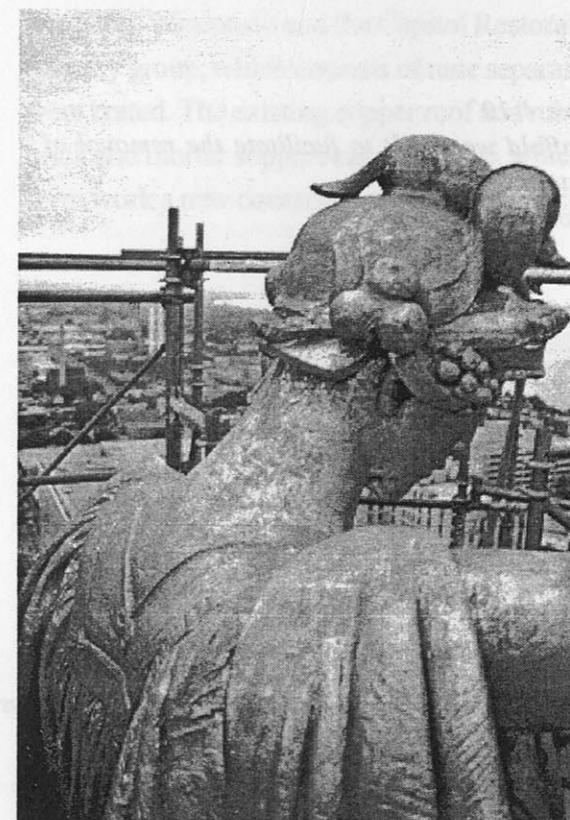
Numerous areas of degraded surface are noted throughout the statue, such as metal corrosion, paint system failure, and lost gilding. The degradation falls into two categories: pinhole losses and large overall surface loss . . . the zinc chromate priming and gilding done in 1957 was uneven in application. . . . This pattern of degradation was noticeable from the ground and was the primary reason for the . . . regilding effort.<sup>34</sup>

Figure 4-15  
The back side of the statue displays its bare metal condition after all previous coatings were removed.  
Photo: Mike Bath

During the regilding project "Wisconsin" was high pressure washed with water and, after numerous tests with solvents, cleaned to remove all old gold, size, zinc chromate, and foreign materials. Holes needing repair were drilled and tapped for new bronze screws, which were then chased. Previous solder fills and structural seams were examined to determine appropriate repair. A red oxide primer was sprayed before "Tiente Dure" zinc chromate was applied as a base for the sizing. Oil size was applied prior to the 3 ° K XX Antique Doublegold loose gold leaf. About 12,275 sheets, approximately 3" x 3" each, were used. The statue was then burnished with a squirrel hair brush. Due to wind storm damage during the project, the extended arm, from shoulder to finger tips, was regilded by

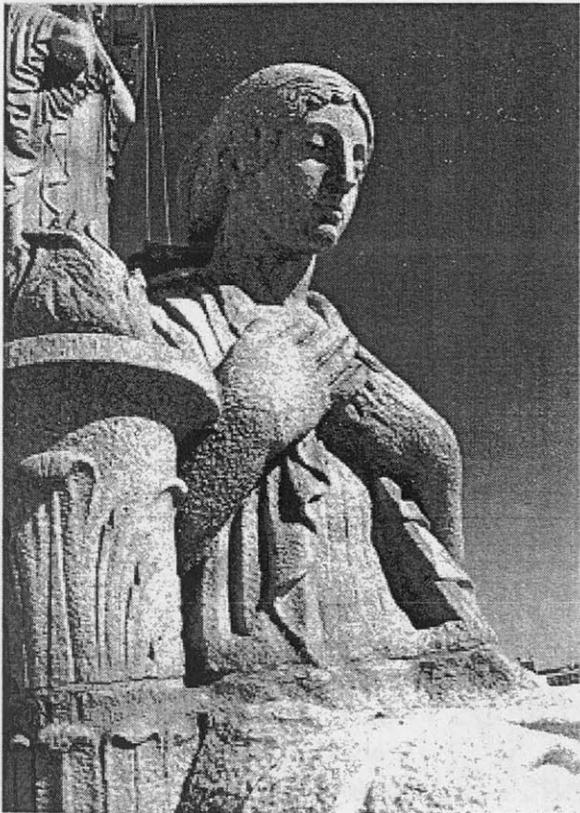
*Figure 4-22*  
A statue in the "Faith" statuary group exhibits a typical example of exfoliation where pieces of the granite have delaminated.  
Photo: Wiss, Janney, Elstner Associates, Inc.

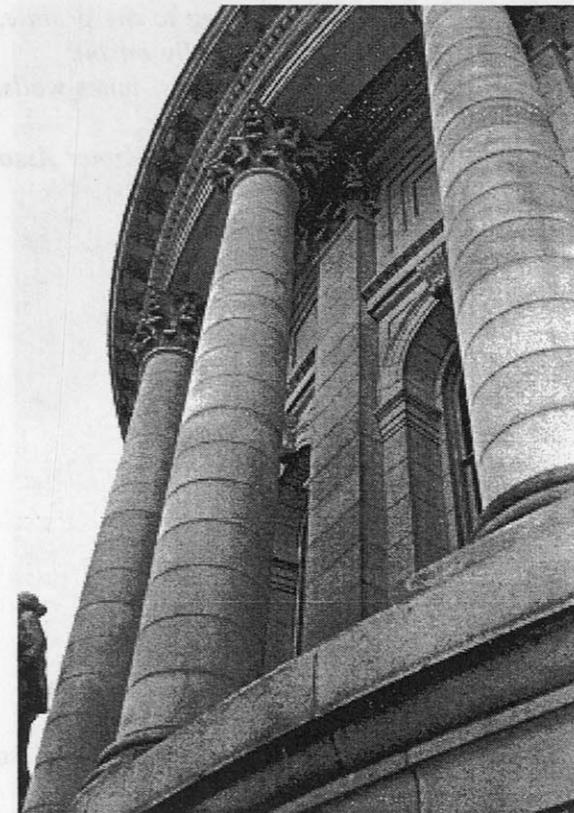
vidual units vary slightly in color and texture. Localized mottled areas of the granite surface may vary more significantly, with a pronounced difference in appearance. These areas appear blotchy, with an uneven color ranging from grey to yellow, and sometimes an uneven texture accompanies the mottled area. Severe mottling was sometimes associated with exfoliation of the granite surface. Mottling was observed in all areas of the building inspected, with the most severe instances at parapets and balustrades.<sup>43</sup>

Natural weathering results in an alteration to the surface structure of the granite to highly laminated structures. This texture permits a buildup of dirt deposits. Surface color variations and discoloration becomes noticeable due to the effects of light. Studies indicate that nonaggressive cleaning methods may mitigate the mottled appearance slightly but do not remove it. As a result, Wiss, Janney, and Elstner stated that "because only aggressive methods that damage the stone, such as retooling or refinishing the stone surface, are likely to remove the mottled appearance, cleaning of the facades and dome would not be effective without damage to the substrate. Retooling would not prevent the mottling from recurring in the future."<sup>44</sup>

*Figure 4-23*  
Uneven or blotchy shades of the granite color are evident on the Corinthian columns at the Inner Drum.  
Photo: Wiss, Janney, Elstner Associates, Inc.

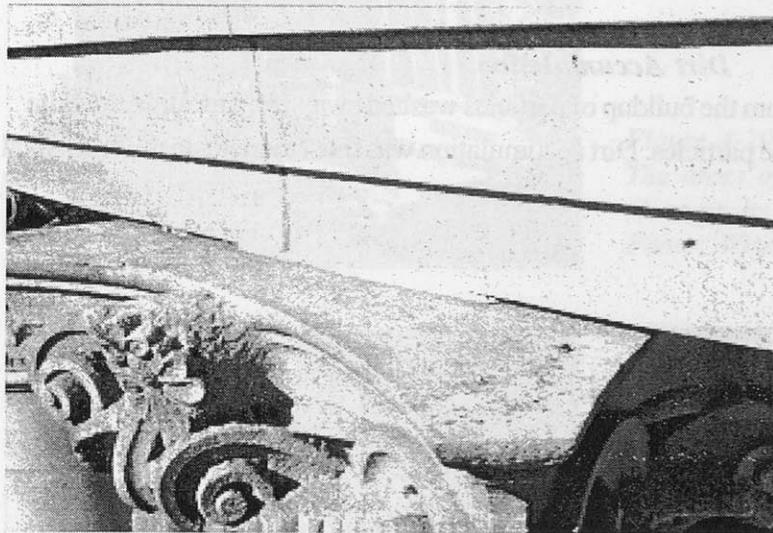
Bird-related distress, evidenced by discoloration and pitting to the granite, is caused by the acidic nature of bird excrement. This was observed at the Lower Drum's inner walls and soffits where several capitals were observed with bird nests and bird excrement. Bird nests were also found at the base of the Lower Drum.<sup>46</sup>

*Figure 4-24*  
*Bird excrement, causing discoloration and pitting to the granite, was found especially on the Lower Drum capitals, inner walls, soffits and at the base.*  
*Photo: Wiss, Janney, Elstner Associates, Inc.*

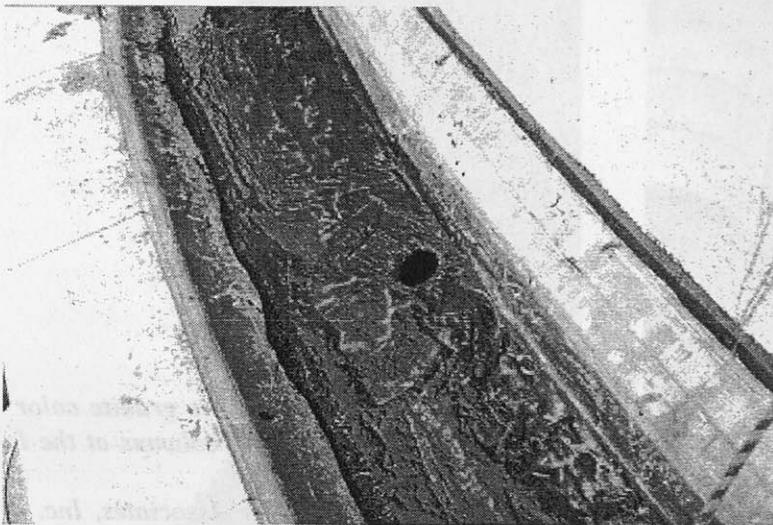
Organic growth, defined as small green plant growth, was found in some areas on north-facing surfaces of walls, especially in shaded areas. Although not necessarily harmful to the stonework, it can result in additional moisture being held against the stone. This growth was not significant in the Central Portion.<sup>47</sup>

*Figure 4-25*  
*Organic growth, though not significant, was found in some shaded areas.*  
*Photo: Wiss, Janney, Elstner Associates, Inc.*

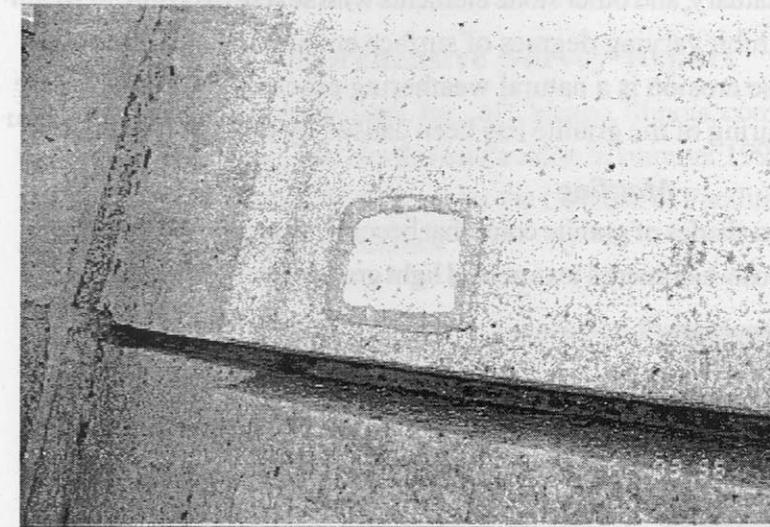
Mortar was originally used between the granite units. During previous repair projects, sealant was used between the granite units, in addition to the mortar, where movement between granite units was anticipated. Conditions observed in the mortar joints included deterioration, loss of bond, cracking, previous repointing, and application of sealant over mortar. The mortar in joints between large granite units throughout areas inspected was found to be in good condition generally, although joints between granite blocks at the Podium Wall cornice and above were observed to have deteriorated. Joints directly above the cornice at the Podium Wall, Lower Drum, and Upper Drum have been covered with sealant, which has deteriorated. The joints between granite units of the statuary at the Lower Drum were also deteriorated.<sup>48</sup>

*Figure 4-26*  
*A representative example of a granite unit indicates the mortar and sealant used at joints for a repair.*  
*Photo: Wiss, Janney, Elstner Associates, Inc.*

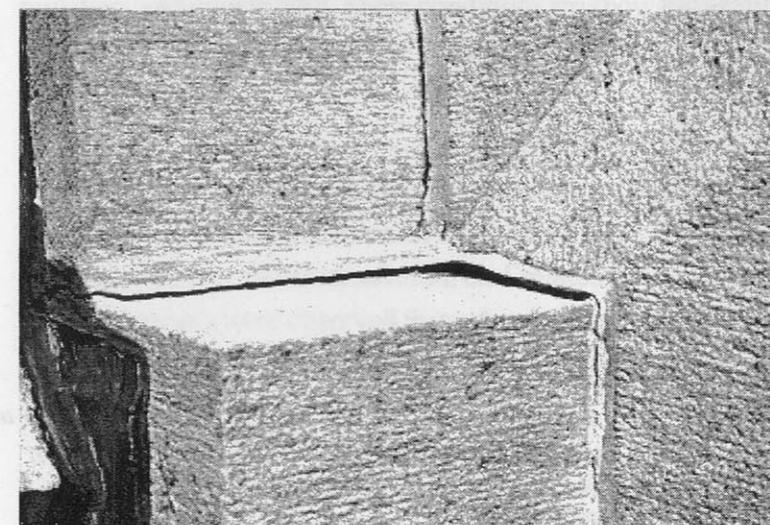
*Figure 4-27*  
*Deterioration of sealant in the joints includes a loss of bond between the granite units.*  
*Photo: Wiss, Janney, Elstner Associates, Inc.*

The joints of the Dome are covered with sealant, which has deteriorated and is in poor condition. The sealant was typically observed to be cracked, alligatored, split, and debonded. Evidence of water previously entering through the Dome joints was found inside at two locations. The condition of mortar joints between the granite panels of the Dome could not be observed due to sealant placement over the mortar joints. Often the granite immediately adjacent to the sealant joints exhibits a dark-colored stain. Joints between Dutchmen repairs and the adjacent granite units were usually found intact and filled with mortar.<sup>58</sup>

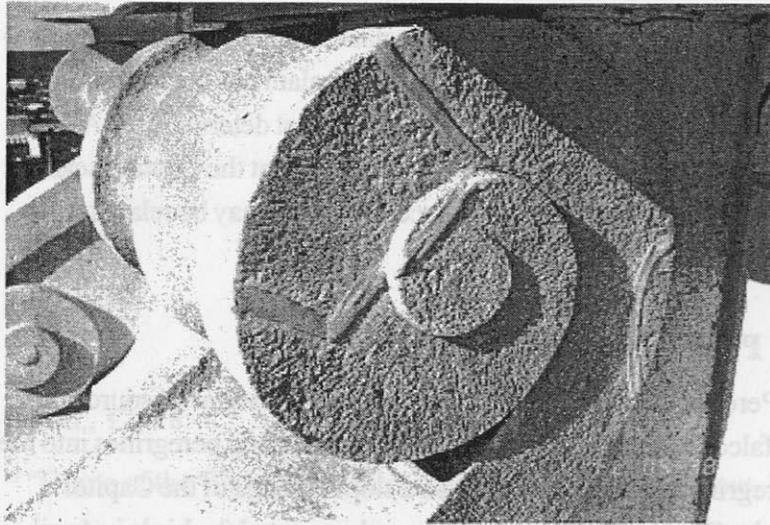
*Figure 4-28*  
Sealant has been applied to scroll work at the base of the Dome where cracking has occurred.  
Photo: Wiss, Janney, Elstner Associates, Inc.

Twenty-one of the twenty-four decorative scroll units at the base of the Dome were observed to be cracked, indicating movement of the Dome base. Several cracks extend through the full height of the scroll unit, with most scrolls observed to be cracked on both the left and right faces. Approximately half the cracks are covered with sealant; the remaining cracks are not sealed. None of the cracked granite units have loose sections of granite.<sup>51</sup>

The cracking pattern of the granite scrolls indicates unaccommodated differential movement between the steel structure of the Dome and the granite blocks. Movement at the support points of the Dome trusses corresponds to the cracks observed in the scrolls because the thinnest portion of the granite cross-section at the Dome base is within the scroll. Typically, expansion joints were not incorporated in the Dome construction. Because the Dome was built using brick masonry, which is

subject to permanent moisture-related and cyclical temperature-related expansion, expansion of the cladding system occurs. Differential movement also occurs between the Dome cladding and the Dome structure due to differences in construction materials. Cracking can result where Dome movement and differential movement are not accommodated by the joints. Cracking of the scrolls may also be related to high stresses caused by the weight of the granite above the scrolls.<sup>52</sup>

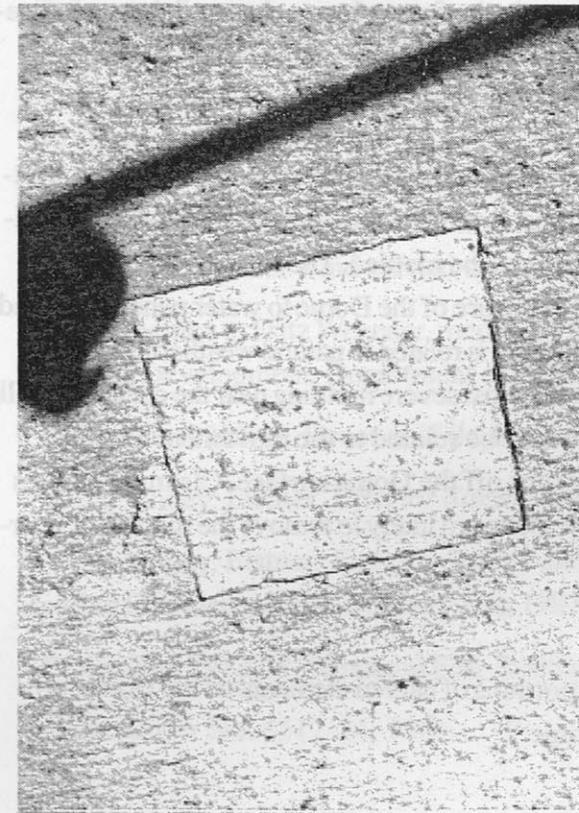
A Dutchmen repair involves removing a deteriorated piece of granite by making square cuts in the granite around the deterioration. A precut granite piece that matches the surrounding configuration is inserted into the opening. Dutchmen repairs were observed throughout.

*Figure 4-30*  
This granite unit features a Dutchmen repair, where a precut granite piece is inserted into a worked opening that had previously deteriorated.  
Photo: Wiss, Janney, Elstner Associates, Inc.
