## Chapter Four EXTERIOR

**HISTORIC STRUCTURE REPORT  
WISCONSIN STATE CAPITOL  
CENTRAL PORTION**

## Central Portion Description

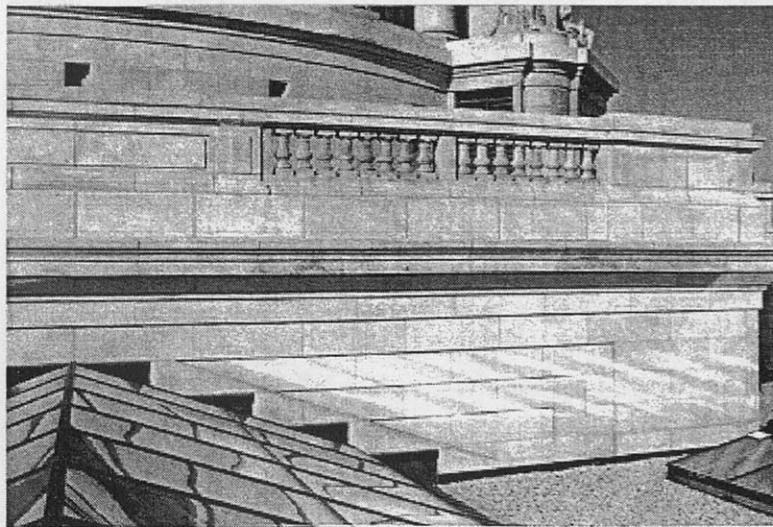
*Figure 4-3*  
The Podium Wall, rising above the roofs on the wings, separates the Central Portion from the wings.  
Photo: Wiss, Janney, Elstner Associates, Inc.

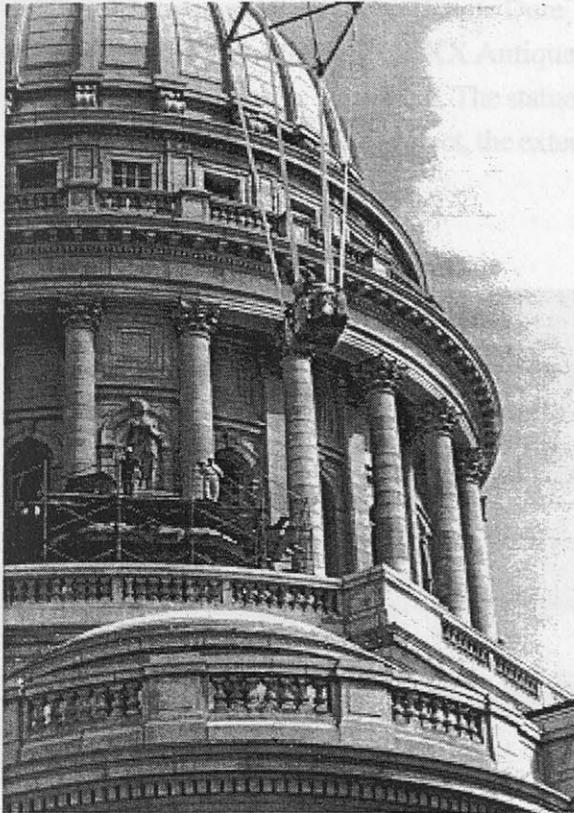
Original roofing materials on the pedestals supporting the Seventh Level statuary included copper sheets that extended underneath the statues. After subsequent roofing projects the copper was covered with a rubber membrane. Due to deterioration of both the copper and the membrane, severe water damage occurred to the interior finishes of the Upper Sixth Level. To correct the continual water leakage, all old roofing materials were removed and a new roofing system installed. This necessitated removal of the statuary groups during the roofing removal and installation process.

*Figure 4-10*  
*A scaffold was built to facilitate the removal of the statuary pieces.*  
*Photo: Kahler Slater*

The project was undertaken 5-30 August 1996 through the management of J.P. Cullen & Sons, Inc., of Madison, Wisconsin and the Capitol Restoration team. A 25 story-tall, 500-ton crane lowered each statuary group, which consists of nine separate granite pieces, to the Capitol grounds where the statues were crated. The existing copper roof and rubber membrane were removed along with the existing brick and mortar support base and curb, which were badly deteriorated. After installation of a wood form work a new concrete support base and curb was poured using high-strength, non-shrink grout

with pea gravel. A turn-coated stainless steel roofing was set in place. Each statuary group was returned section by section to the original locations. The mortar joints were carefully studied before disassembly so the joint width could be replicated. A variety of plastic shims were used to maintain the correct space between the granite pieces when the new mortar was applied.

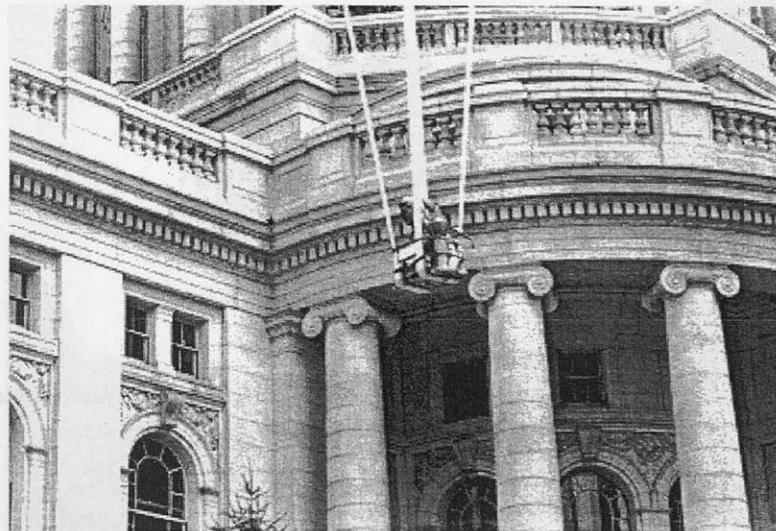
*Figure 4-11*  
*Custom designed, a strapping system secured each statuary piece as it was lowered to the ground.*  
*Photo: Kahler Slater*

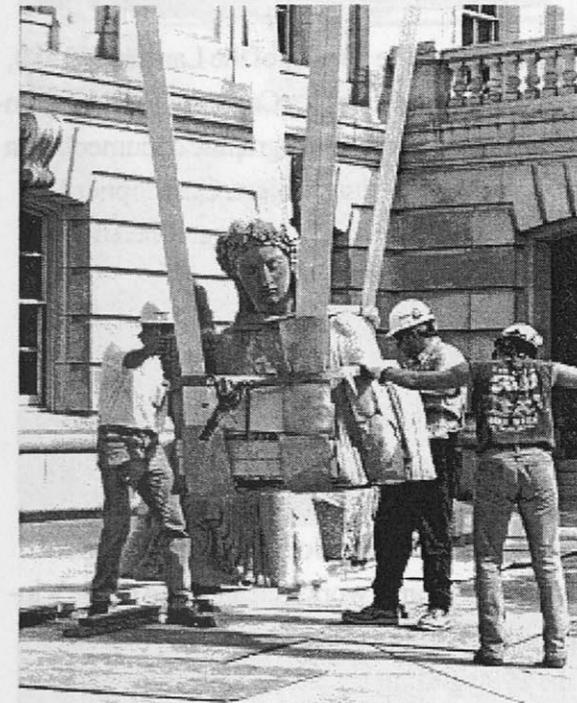
*Figure 4-12*  
*Each statuary piece was lowered carefully to the ground during removal. Hoisting each piece to its original location occurred in reverse order.*  
*Photo: Kahler Slater*

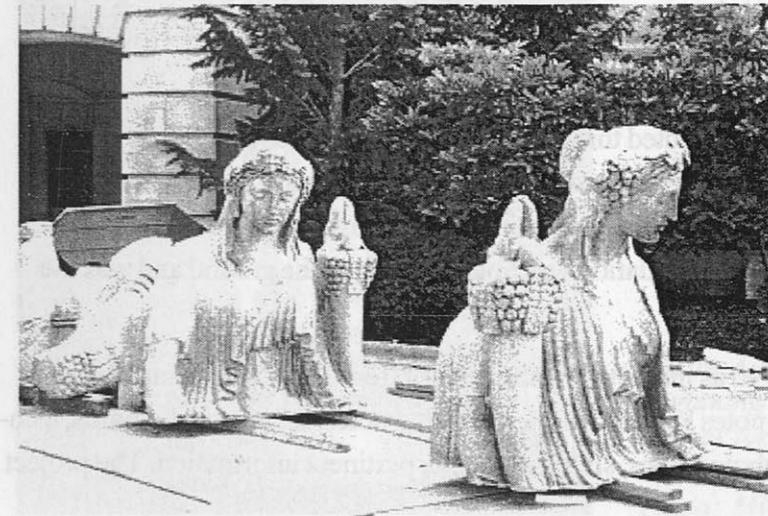
*Figure 4-13*  
*The granite pieces from one statuary group are placed on skids ready to be crated.*  
*Photo: Kahler Slater*

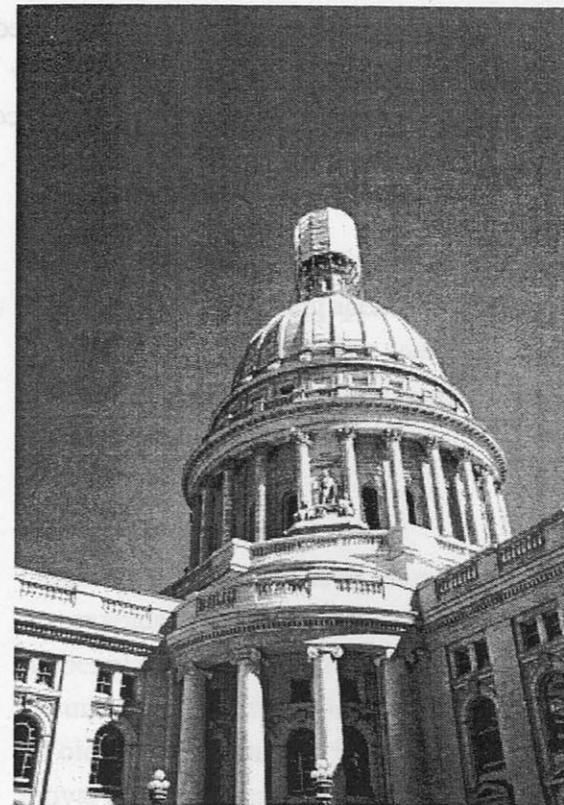
Numerous areas of degraded surface are noted throughout the statue, such as metal corrosion, paint system failure, and lost gilding. The degradation falls into two categories: pinhole losses and large overall surface loss . . . the zinc chromate priming and gilding done in 1957 was uneven in application. . . . This pattern of degradation was noticeable from the ground and was the primary reason for the . . . regilding effort.<sup>34</sup>

Figure 4-14  
Scaffolding was set in place around the statue to protect the gilding team from the weather's elements.  
Photo: Mike Bath

During the regilding project "Wisconsin" was high pressure washed with water and, after numerous tests with solvents, cleaned to remove all old gold, size, zinc chromate, and foreign materials. Holes needing repair were drilled and tapped for new bronze screws, which were then chased. Previous solder fills and structural seams were examined to determine appropriate repair. A red oxide primer was sprayed before "Tiente Dure" zinc chromate was applied as a base for the sizing. Oil size was applied prior to the 3 ° K XX Antique Doublegold loose gold leaf. About 12,275 sheets, approximately 3" x 3" each, were used. The statue was then burnished with a squirrel hair brush. Due to wind storm damage during the project, the extended arm, from shoulder to finger tips, was regilded by

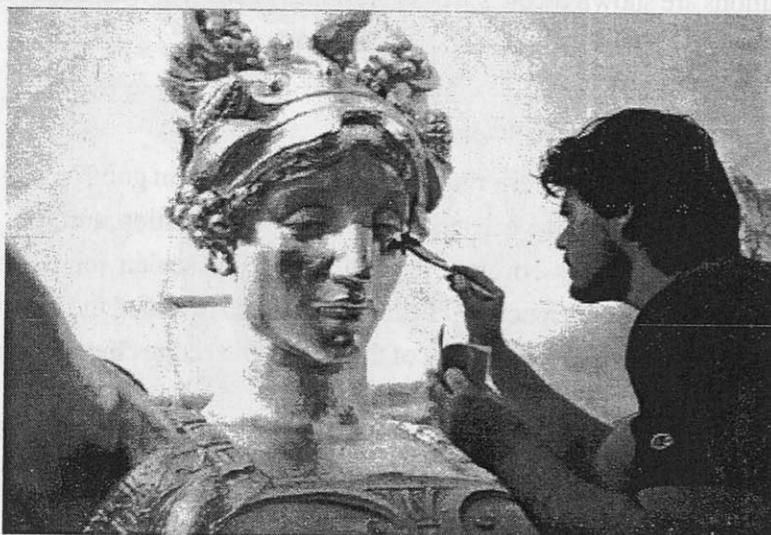
*Figure 4-17*  
A gilder from the project team applied 3 1/2 k XX Antique Doublegold loose gold leaf to the statue.  
Photo: Mike Bath

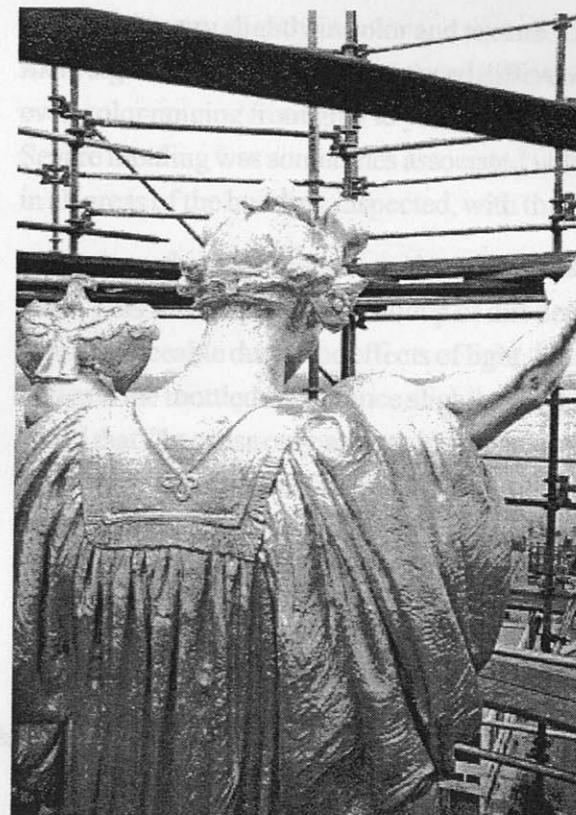
*Figure 4-18*  
The back side of the statue displays its new appearance with all the gilding completed.  
Photo: Mike Bath

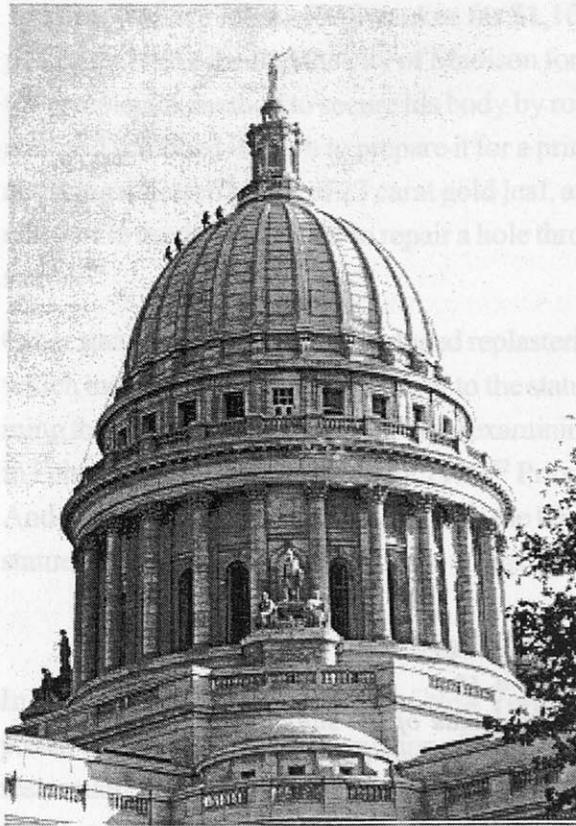
*Figure 4-20*  
*The areas of the Dome and Drum were inspected close-up by rappelling.*  
*Photo: Wiss, Janney, Elstner Associates, Inc.*

The Podium Walls were inspected from the Third and Fourth Floor roofs. The areas of the building above the Observation Level, which includes the Dome and Drum, were inspected close-up by rappelling. Survey forms incorporated field notes, sketches, and photographs. The survey forms also included baseline drawings adapted from selected original drawings. Survey findings for the condition of the granite walls include deterioration, building wall movement, exfoliation, mottling, erosion, dirt accumulation, and joint failure. These conditions are shown on the specific elevation drawings, which may be referenced in Appendix D of the Wiss, Janney, Elstner Associates, Inc., Report.

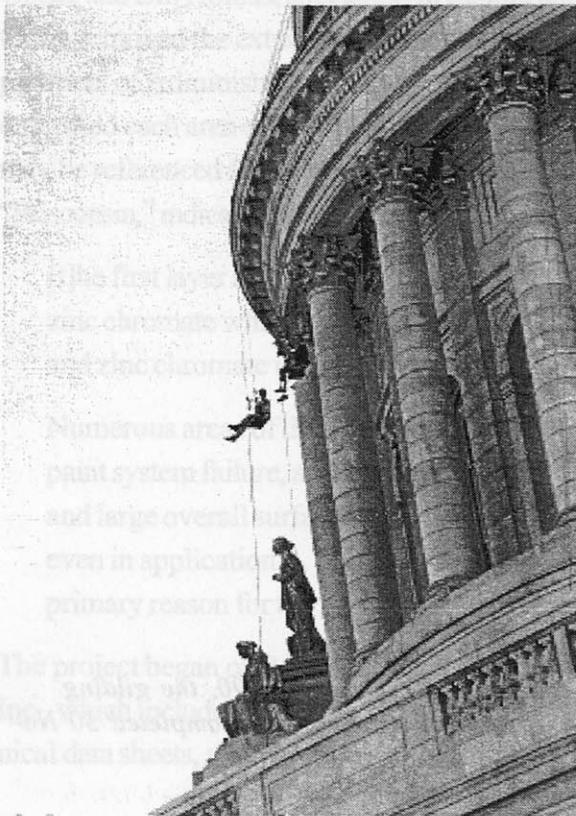
*Figure 4-21*  
*All areas above the Observation Deck were inspected by the Wiss, Janney, Elstner team in 1993.*  
*Photo: Wiss, Janney, Elstner Associates, Inc.*

Wiss, Janney, Elstner Associates, Inc., determined the exterior granite on the Capitol is in good condition generally, although some individual units of granite have deteriorated. Surface exfoliation, surface erosion, mottling, dirt accumulation, bird-related distress, organic growth, mortar and sealant joints, and previous repairs were observed throughout the areas inspected. The inspection also revealed the following conditions observed at specific locations: cracks, displacement of the stone units, edge chips, spalls, and imminent spalls.<sup>39</sup>
